CH100

Cap Fastener Upgrade

***Field Service Bulletin
802240 - Revision 1***

Revision 1 August, 1995

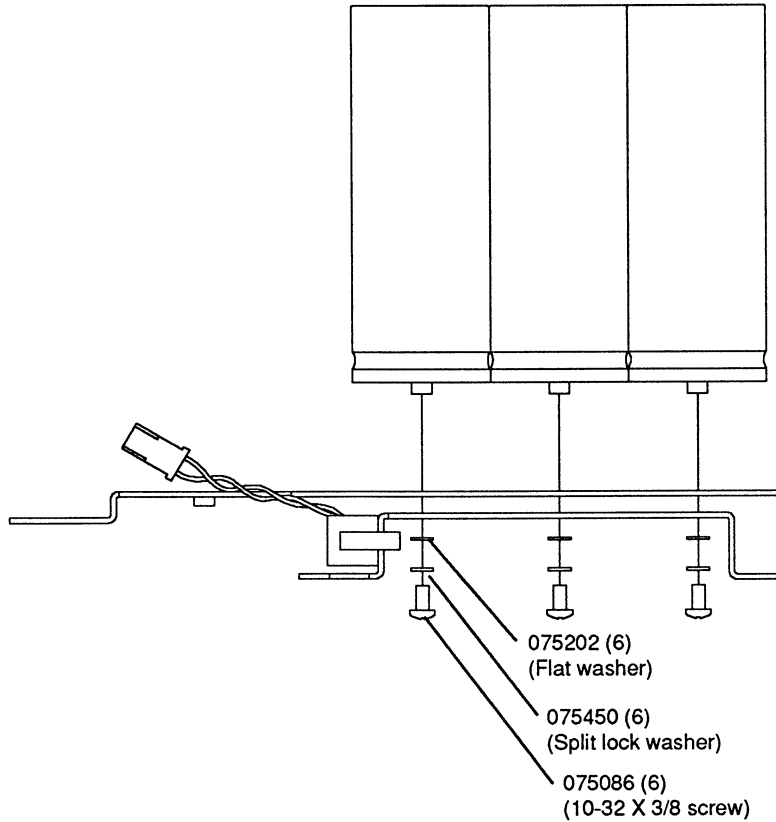
Figure 3 Capacitor Fastener Upgrade

This upgrade is an improvement to earlier capacitor fastening designs for the CH100 chopper. Under certain conditions, the internal star washers on earlier units can cause arcing and increase electrical resistance which could result in failure of the large capacitors.

7. Remove capacitors from bus bars and discard capacitor fastener hardware (six (6) screws and twelve (12) internal lock washers per chopper).

8. Install new hardware from kit as shown in Figure 3. **Be certain that capacitor polarity is correct when fastening to bus bars!** See Figure 4.
