PAC611

Torch Insulator Upgrade

Field Service Bulletin
802330 - Rev. 0

Revision 0 September, 1995

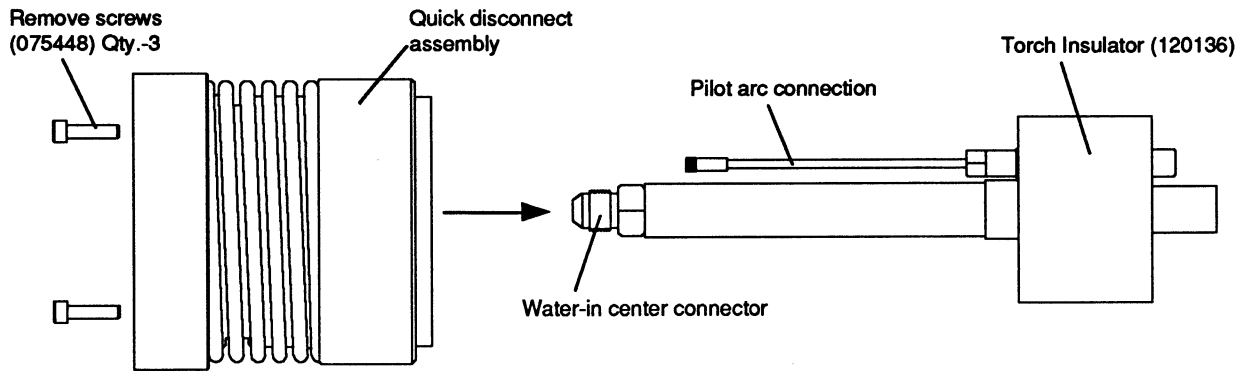
Figure 6 Removing Torch Insulator from Quick Disconnect

2. Remove 3 screws (075448) that connect torch insulator (120136) to quick disconnect assembly. Torch insulator with attached pilot arc connection and water-in center connector will fall out easily.

1. Take new modified torch insulator and install in quick disconnect assembly by reversing instructions in this bulletin. Note: Replace all retaining rings with stainless steel retaining rings supplied with this upgrade.
2. PAC611 torch insulator upgrade is complete.

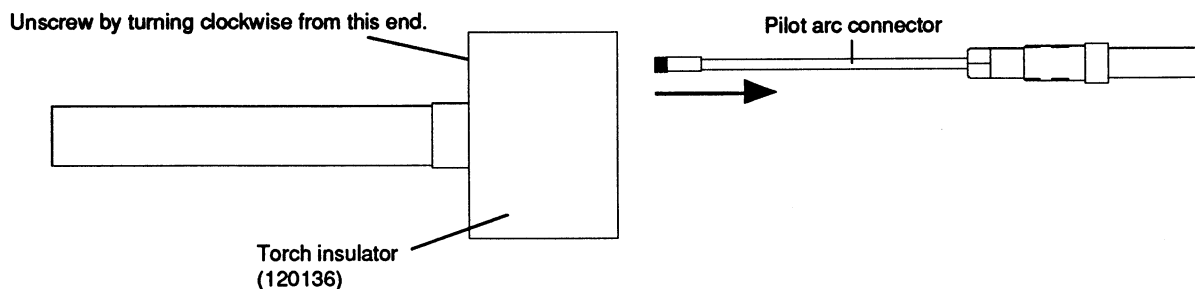
Figure 8 Removing Pilot Arc Connector from Torch Insulator

4. Unscrew pilot arc connector from torch insulator by turning clockwise on the hex portion of the connector until the connector drops out the other end. See Figure 7 for before and Figure 8 for after pilot arc connector removal.
