Installation of HT2000 Firmware for Improved 100 Amp Oxygen Cutting

Kit: 128056

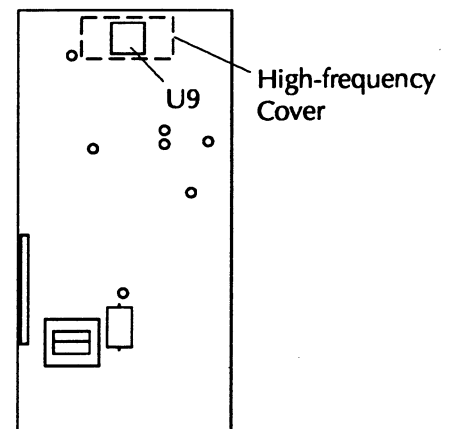
Figure 2 HT2000 Control Board PCB2

4. Find Control Board PCB2 and firmware IC **081004**. Firmware IC is located in socket labeled **U9** underneath high-frequency cover. See Figure 2.
