Hypertherm[®]

Phoenix[®] Software Version 10.7.0

출시 정보

809720KO | 개정 8 | 2018년 4월

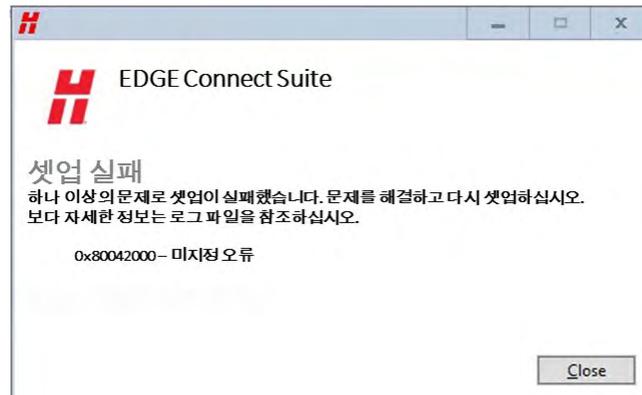
- ProNest CNC 세그먼트 설치 시 EDGE Connect Suite 설치가 실패했던 문제를 해결했습니다. 설치 실패 오류 메시지가 오류 코드 0x80042000와 함께 표시되었습니다(지정되지 않은 오류).

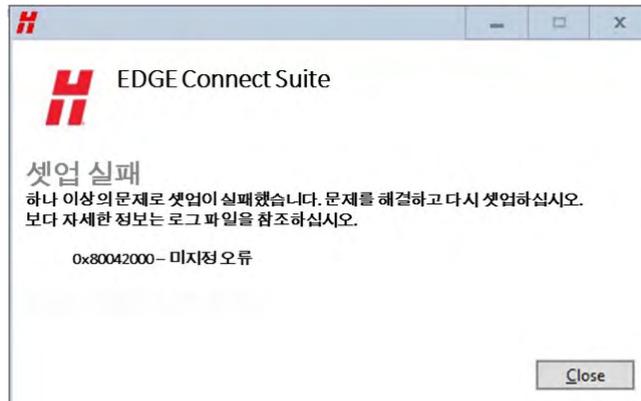
- Resolved an issue where the EDGE Connect Suite installer failed during the ProNest CNC segment of the installation and the message shown below was displayed.
