CH100

Cap Fastener Upgrade

***Field Service Bulletin
802240 - Revision 1***

Revision 1 August, 1995

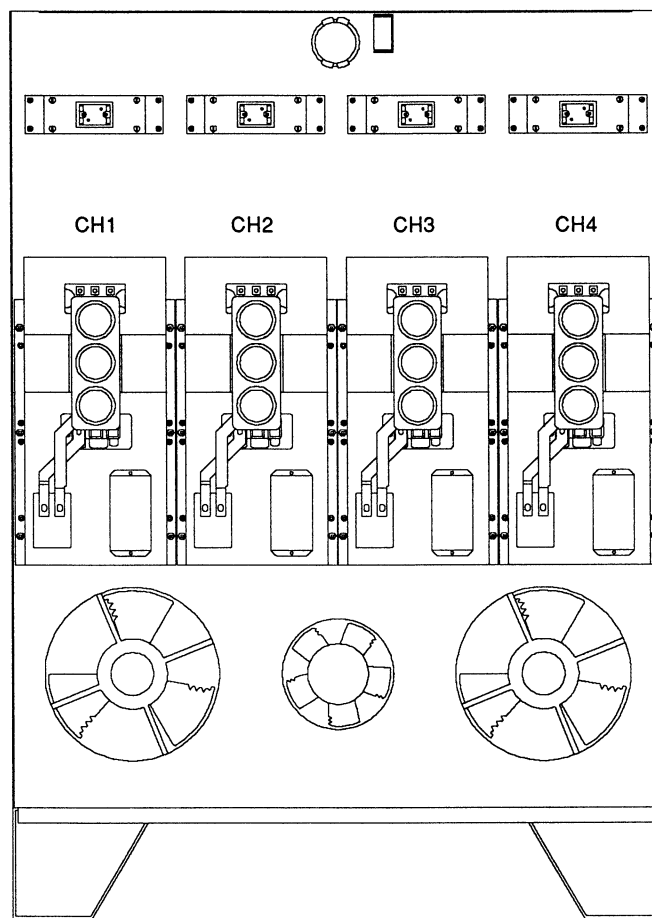
Figure 1 - HT4001 CH100 Choppers

Looking at the inside front wall of the power supply, the choppers are designated CH1, CH2, CH3 and CH4 looking from left to right. Cables correspond to this arrangement by being labeled 1, 2, 3, 4 or A, B, C, D.

After modification, be certain to reconnect choppers exactly how they were disconnected!
