Installation of HT2000 Firmware for Improved 100 Amp Oxygen Cutting

Kit: 128056

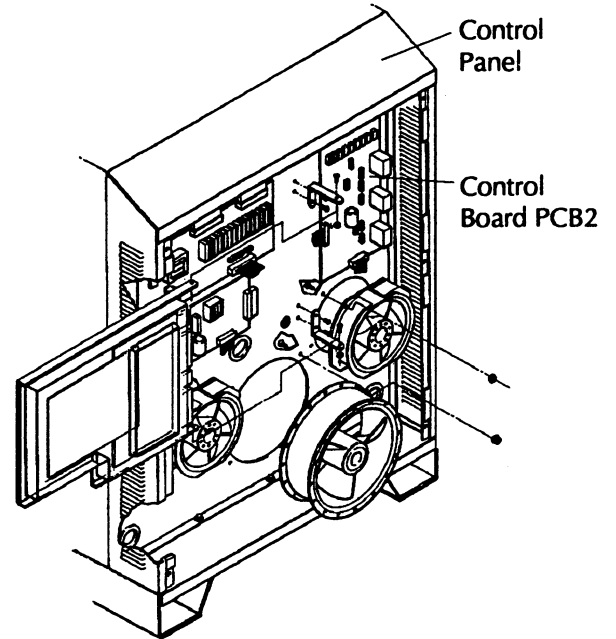
Figure 1 HT2000 Power Supply

1. Disconnect power from HT2000 system - see warning above.
2. Remove front panel of power supply.
3. Unscrew control panel and rotate it to sit on top of the power supply with the electrical wires still attached.
