Consumable inspection visual aid

©4/2023 Hypertherm, Inc. Revision 4 897670EN-EU For HPR[®] cartridge: Refer to shield images to assess wear.

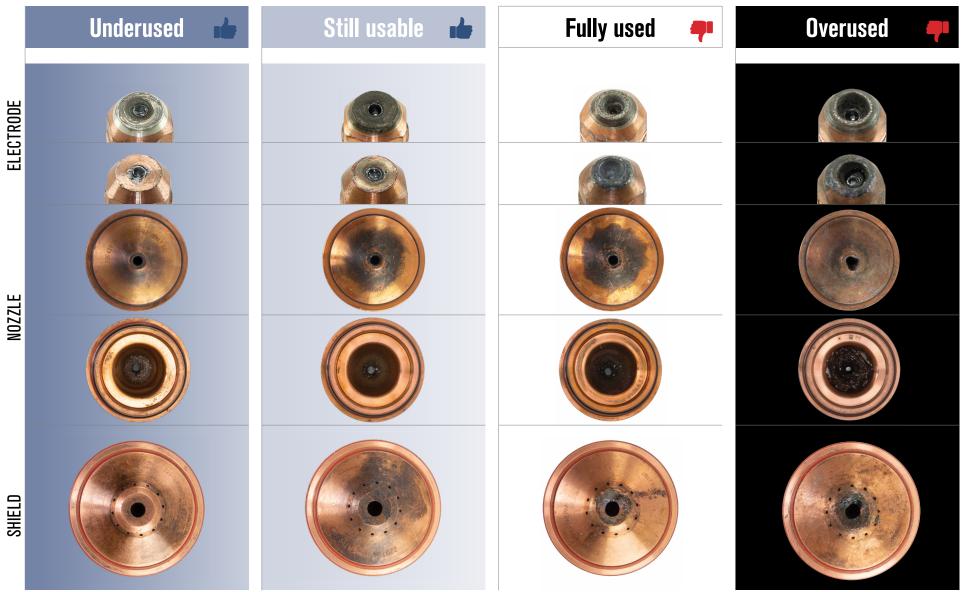
A new electrode wears rapidly for the first 10% of life.

Copper body should remain clean and shiny even at end of life; signs

of gravish heat discoloration could indicate a cooling issue within

The material around the hafnium is eroded and a crater has formed at the tip of the electrode.

Misfires can occur when pit depth gets too deep as the heat transfer properties start to fail and electrode melts rapidly

SilverPlus: Pit-depth is greater than 3 mm (.100").

Copper: Pit-depth is greater than 2 mm

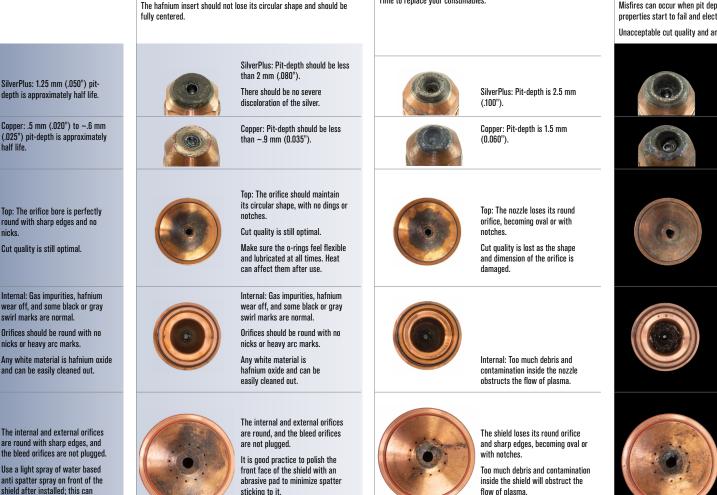
SHIELD

the arc is not centered. Replace shield if any deep scratches or gouges present. This may indicate the torch has crashed into the plate.

wear off, and some black or gray swirl marks are normal. Orifices should be round with no nicks or heavy arc marks.
